## FACILITY STATUS CHANGE FORM

<b>Date Submitted:</b> January 25, 2013 <b>Originator:</b> Chris Strand <b>Phone:</b> 554-2720	<b>Area:</b> 300 Area <b>Facility ID:</b> 3707H <b>Action Memorandum:</b> Action Memorandum #1	<b>Control #:</b> D4-300-079
---	---	---------------------------------

#### 3707H Craft Change House

# 300 D4 3707H Slab Excavation GPERS Radiological Survey Gamma Track Map

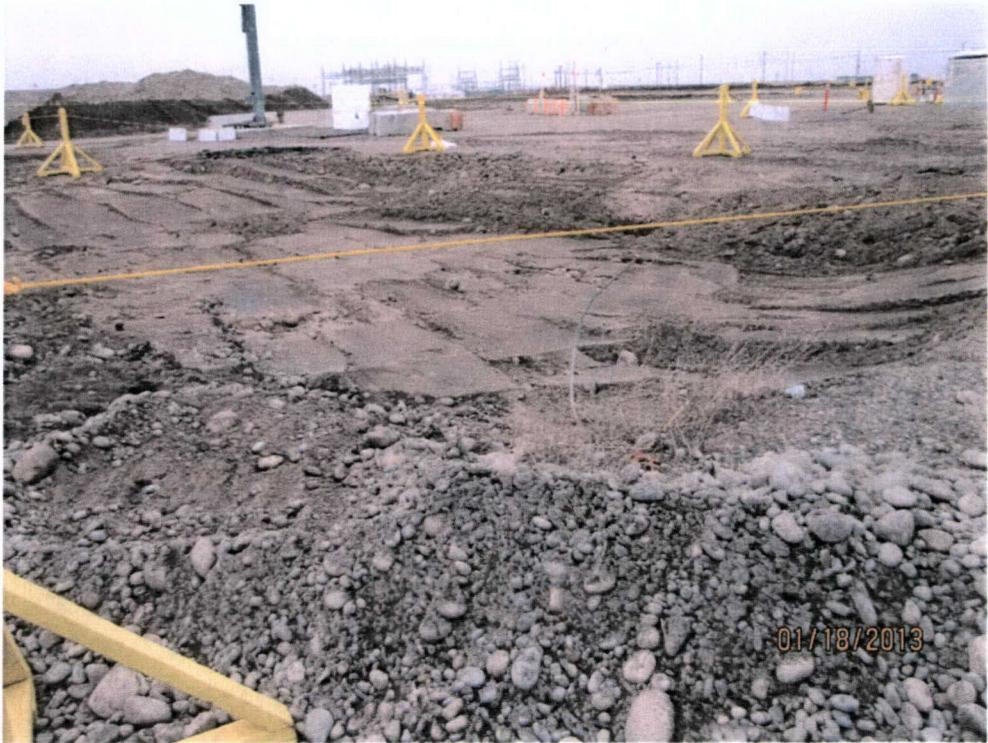
**Photograph 3. 3707H excavation looking northwest, January 18, 2013.**

No anomalies were discovered during demolition. Soils beneath the slab and foundation displayed no visual evidence of staining or discoloration. A final GPERS survey of the excavation following below-grade demolition identified no radiological contamination.

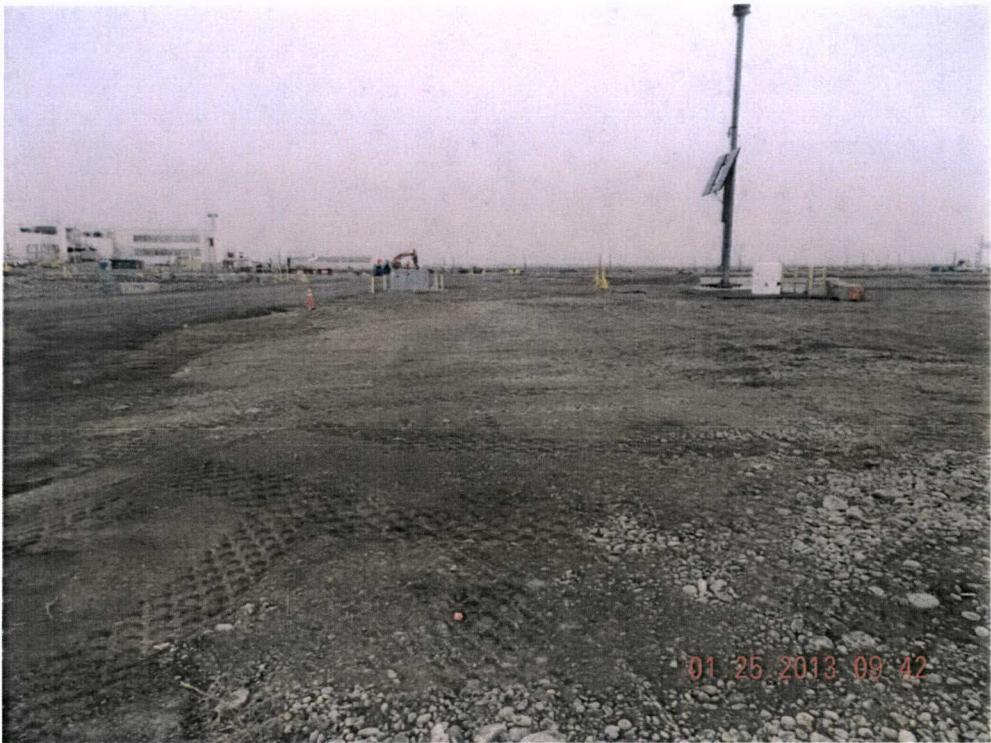
**Photograph 4. 3707H backfilled, looking west on January 25, 2013.**

All above-grade structures and foundations were removed. Excavations were backfilled to grade with clean fill. GPERS surveys were performed prior to backfill. No radiological or Industrial Hygiene postings remain.

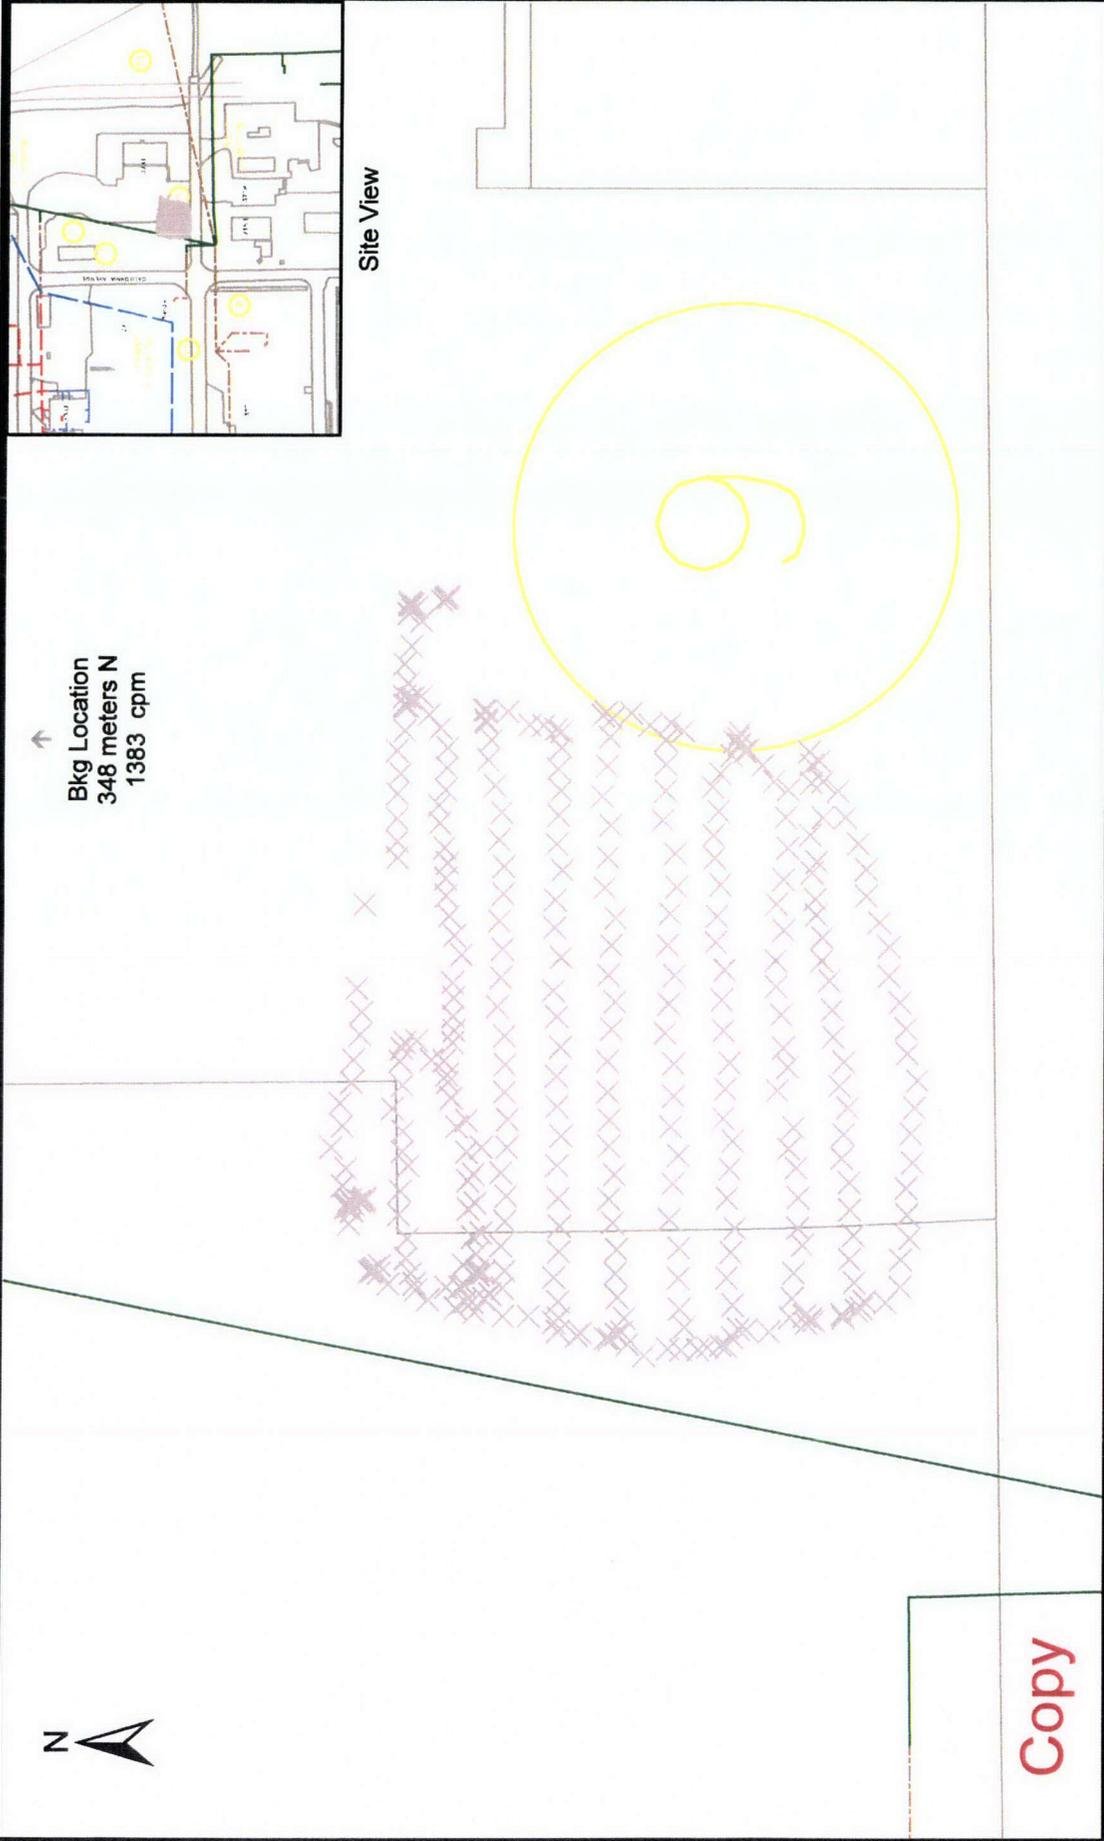
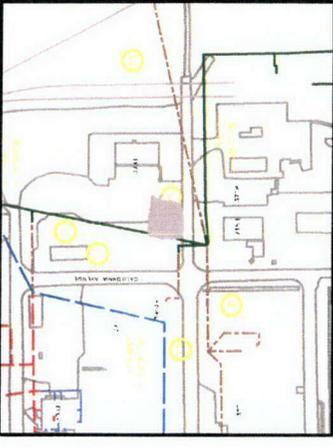
**Attachment 3: GPERS Survey of the 3707H Excavation  
Prior to Backfill**

- Coverage File: D4\_021
- Number of Data Pnts: 369
- Type of Survey: gamma
- Max GCPM: 2377
- Avg Bkg CPM: 1383
- Survey Date: 1/21/2013
- Area Surveyed: 60 m<sup>2</sup>
- Project File: ESRFRM130008
- Pdf File: ESRFRM130008C
